Confidential Survey of Condition and Value,

M/V TOP COVER

26 April 2023

File # 12323

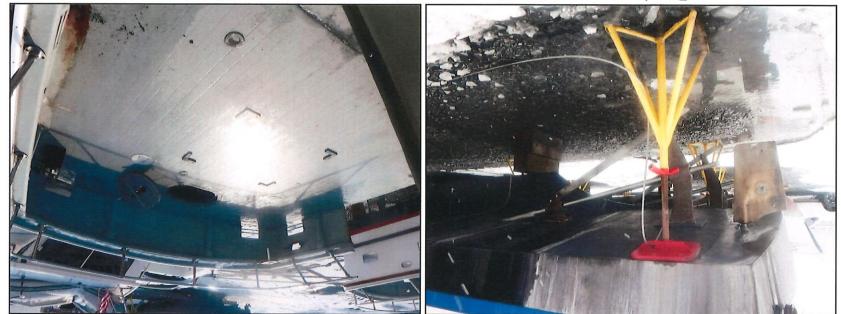
Running gear

- through hull-mounted packing glands and riser tubes with upper and lower RUDDER(S): (2) semi-balanced design cast bronze on 1-3/4" stainless alloy stocks, bushings, good condition.
- THROUGH HULL FITTINGS: Bronze, approved type, each fitted with operable marine valves, in good order.
- RUNNING GEAR: The shafts are through Cutless bearings mounted in forward and aft I-struts, with a bolted skeg below, struts, light bearing wear with runout <1/16", in good order.

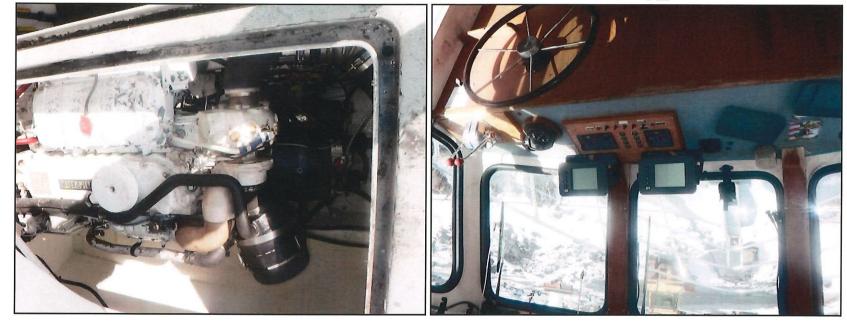
Port engine

Two Caterpillar model 3126 six-cylinder diesels, port serial #3GS01281, and starboard # 3GS01283. Both are rated 315 horsepower, are turbocharged, electric start, fresh water and heat exchanger cooled and with seawater-cooled exhausts, and drive Twin-Disc model MG-5075 hydraulic reverse and reduction gears at 2.05:1 ratio, to one piece 2" stainless alloy propeller shafts through conventional type packing glands at the stern Ducting to the atmosphere provides adequate ventilation and air supply. The machinery is tubes. There are 303 service hours indicated port and 304 starboard since major overhaul. a replacement from original and appears in good repair.

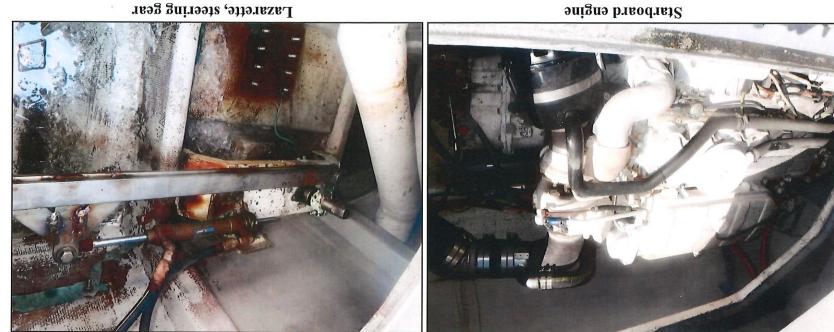
Lazarette, steering gear

single Sea Star hydraulic ram connected to the 1-3/4" stainless steel rudder stocks' tiller arms, which are in turn linked by a stainless steel crossbar; the stocks are through conventional type packing glands atop riser tubes to the hull bottom. Twin screws serve as emergency steering. The steering в controls driven hydraulic pump directly gear appears in good order. A helm

- -1) Wingnuts securing large battery cables to the terminals should be replaced with hex nuts. (ABYC E-10.8.3)
- -2) The aft end of the boarding gate has cracked FRP; recommend grind out to sound material and rebuild to match remainder.
- -3) The pilothouse top aft corners both sides have cracked FRP indicative of freeze/thaw damage from a leak at a fastener atop the pilothouse; recommend grind out to sound material and rebuild to match remainder and ensure any leaks are cured.
- -4) The lazarette hatch should be serviced and adjusted to make watertight.

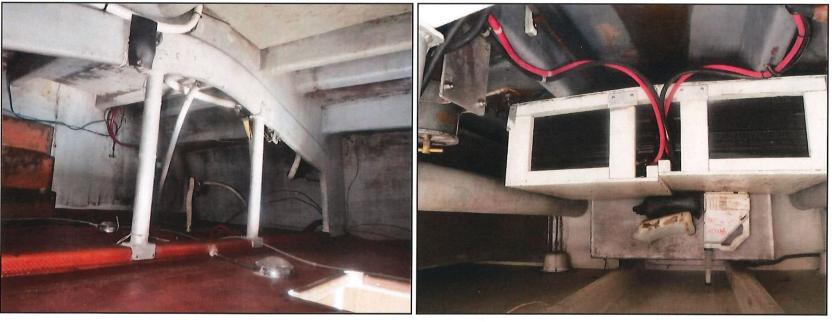
Batteries, tanks

The tanks listed as visible for examination and the associated fittings, piping, and valves appear in good repair.
